**US Army Corps  
of Engineers**  
Waterways Experiment  
Station

Technical Report REMR-CS-49  
June 1995

*Repair, Evaluation, Maintenance, and Rehabilitation Research Program*

## **Applications of Precast Concrete in Repair and Replacement of Civil Works Structures**

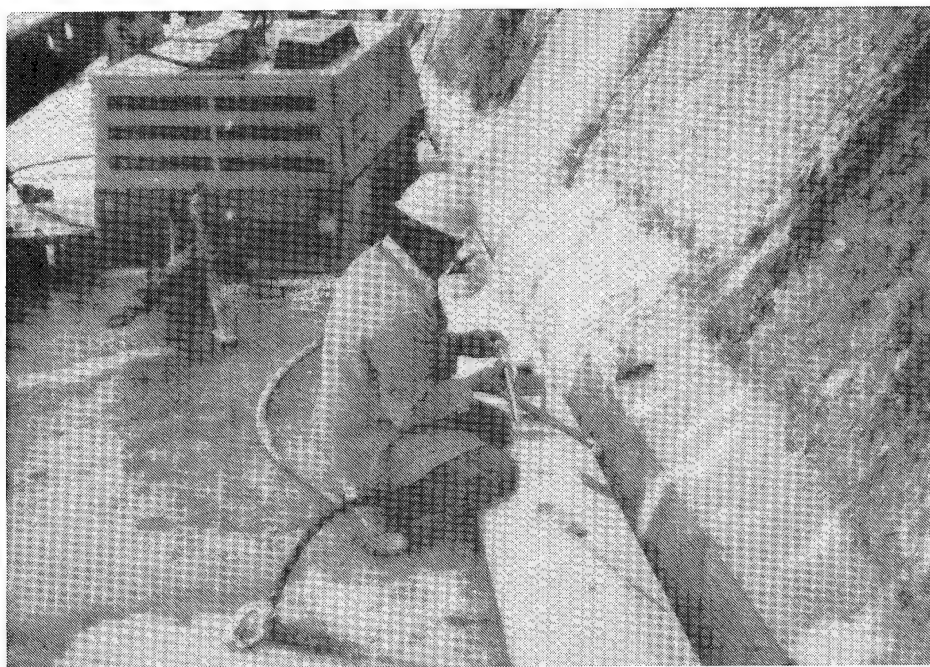
Figure 23. Precast base installation, Lockport Lock

loose concrete with a high-pressure water jet. Then the precast concrete base was installed. The reinforced concrete base was set along the horizontal surface at the base of the wall (Figure 23). The sections were 7.5 ft long by 7 in. high by 1.3 ft wide at the bottom. Two steel bearing plates were embedded in each section during precasting.

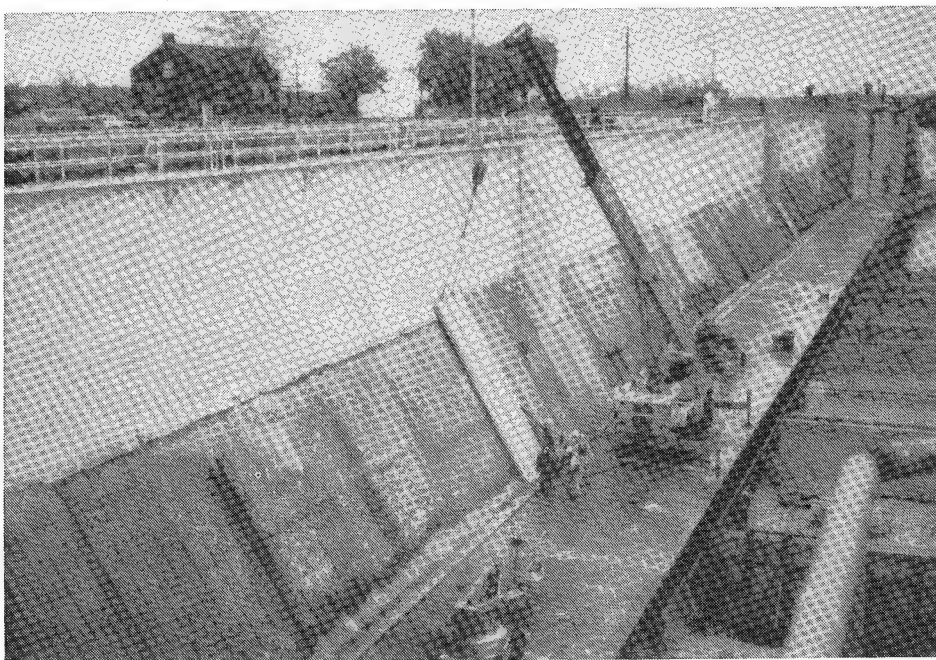
Figure 26. Completed river wall repair, Lockport Lock

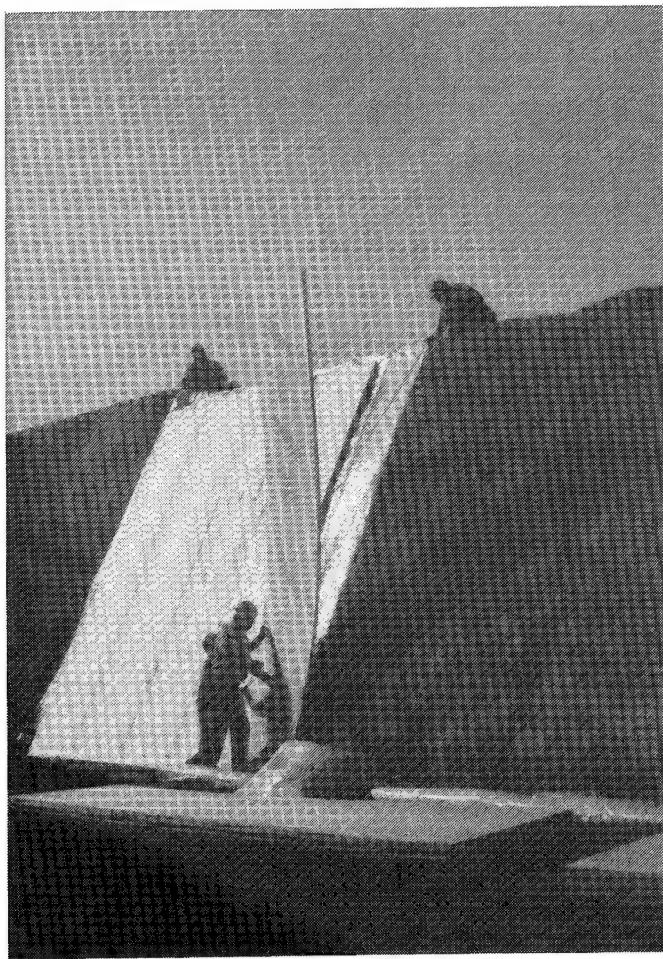
Figure 97. Placing insulation over first vapor barrier, Joliet Channel Wall

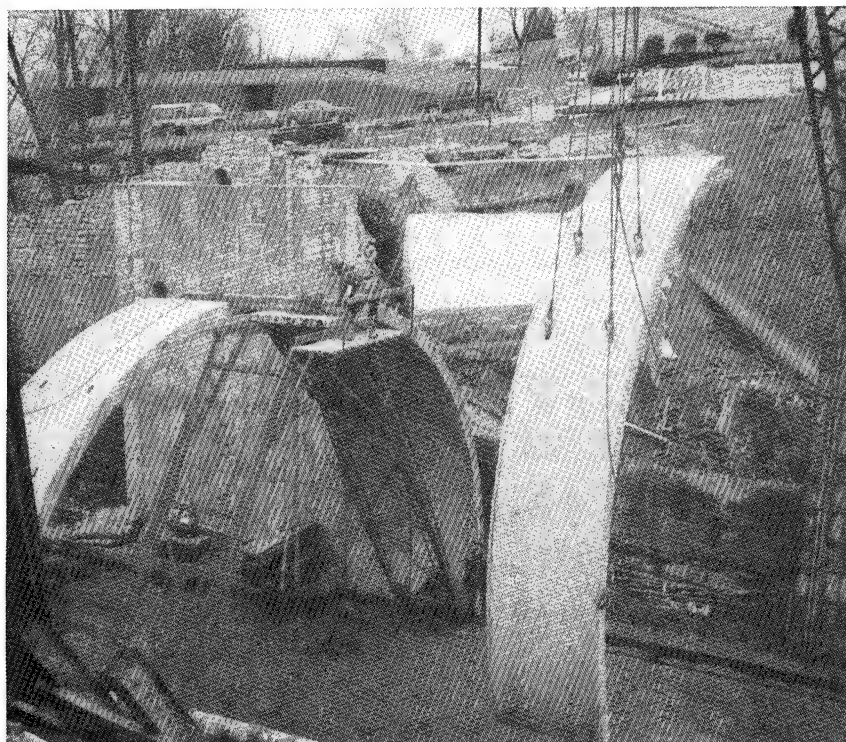
Figure 179. Precast arch sections being installed at Wears Creek  
(from Hurd 1990)
